**Current
Excursion Participant
Safety Advisories
Effective
03/01/2026**

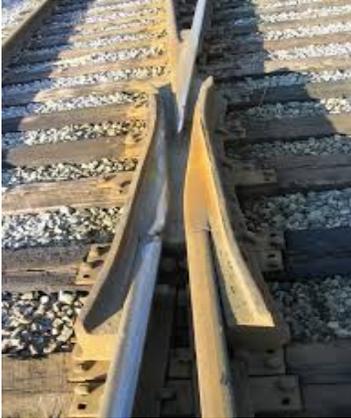
SELF GUARDING FROG

A Self Guarding Frog is identified by guides or flanges, above its running surface which contact the tread rims of railcar wheels for the purpose of safely guiding their flanges past the point of the frog. Self guarding frogs are most easily identifiable by the absence of guard rails on either side of the outer rail. These frogs pose a risk of derailment to track cars due to the lack of these guard rails. Additionally, when the point of a self guarded frog has excessive wear, track car wheels can “jump” over the point and cause a track car to derail. Track car movements turning out through self guarding frogs must not exceed 3 MPH.

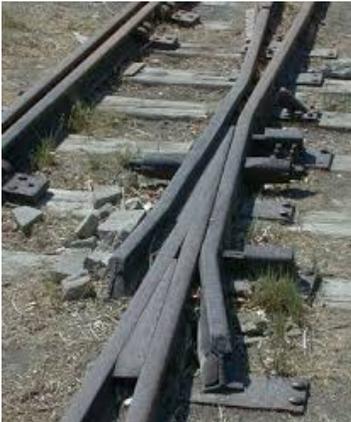
SPRING FROG

A Spring Frog is identified as having a movable wing rail which is normally held against the point rail by springs, thus making an unbroken running surface for wheels using one track. These frogs pose a risk of derailment to track cars as most track cars are too light to overcome the spring pressure needed to open the wing rail for the diverging route. Track car wheels may “walk” up the base of the frog and may or may not follow the intended route through the frog. Track car movements over the closed side of a spring frog must not exceed 3 MPH, prepared to stop if flange does not follow the intended route. Additionally, when available, a person must be on the ground to guard against derailment and guide the track car to the intended route.

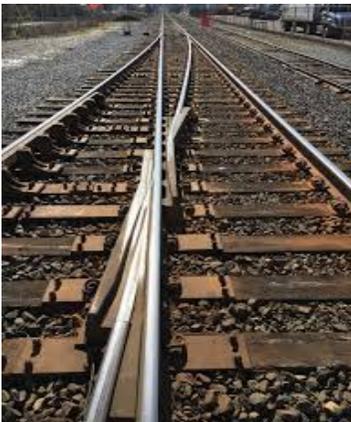
LIFT/JUMP FROG

A Lift or Jump Frog is identified by a continuous stock rail on one side of the frog in which the flange of the wheel on a railcar is lifted up and then rolls over the stock rail. Lift/jump frogs are generally found on lightly used turnouts. These frogs pose a risk of derailment to track cars as the wheel is lifted up and over the stock rail, the track car may or may not follow the intended route through the frog. Track car movements over lift/jump frogs must not exceed 3 MPH, prepared to stop if the flange does not follow the intended route. Additionally, when available, a person must be on the ground to guard against derailment and guide the track car to the intended route.

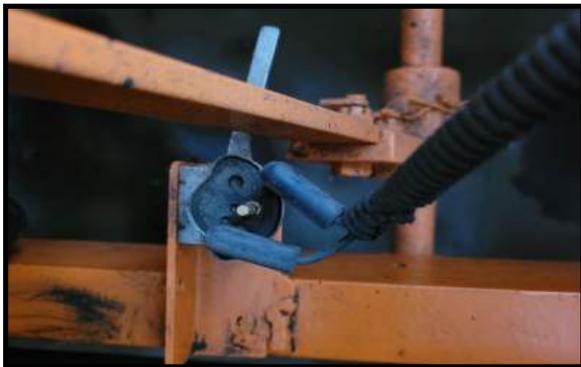
“Disabled Brake Light Switch”

Track car mounted safety devices that become defective or fail en route are not considered purposeful or willful disabling, when the EIC (Employee in Charge) is immediately notified of the failure or defect and proper safeguards are put in place before initiating or resuming movement. Any excursion participant found to have purposely or willfully disabled a track car mounted safety device may be barred from future WCRG excursions.

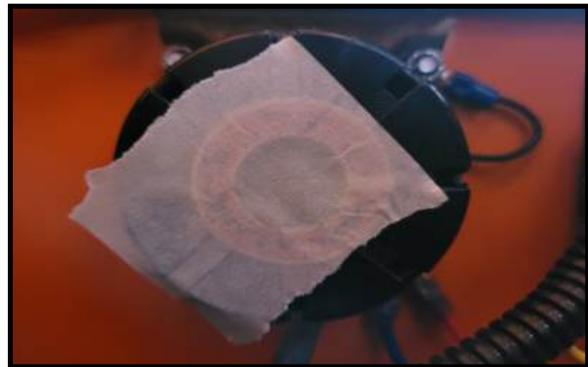
“Taped Over Turntable Alarm”

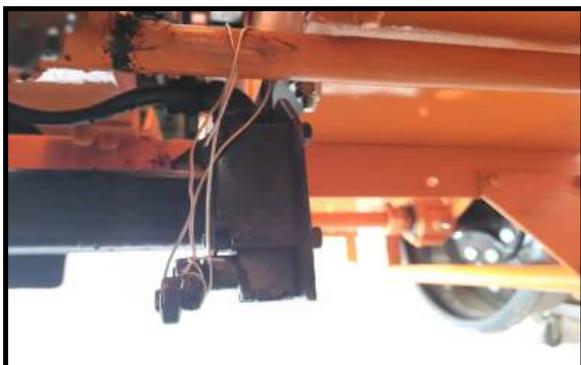
“Disabled Turntable Switch”

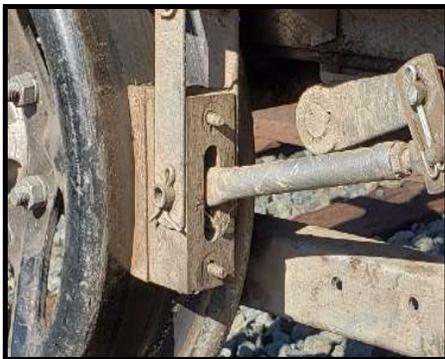
"Missing Brake Shoe Nuts"

The proper maintenance, adjustment, and inspection of your track car's brake system is essential for the safe operation of a track car on WCRG excursions. Excursion participant's track cars must not have any brake defects while operating. Brakes must be properly adjusted, including holding in the first notch. Defective conditions such as loose or missing brake shoe bolts/nuts, improper toggle arm retention hardware, including missing cotter keys, hairpin clips, hitch pins, or other quick release fasteners used in place of cotter pins, as well as jam nuts not tight on the brake arms must be corrected before track car is operated. If defects are found at anytime during an excursion, notify the Employee in Charge at once for any possible movement restrictions.

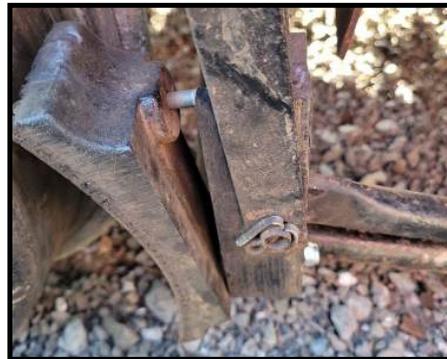
**"Brake Shoe Bolts Loose/
Shoe Separated from Wood Block"**

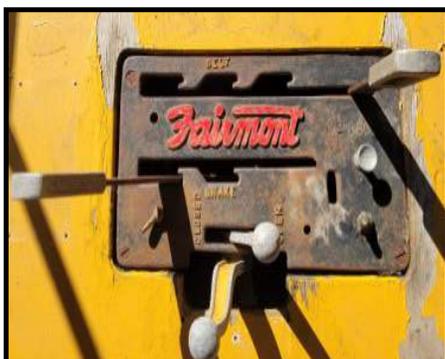
"Brake Handle Not Adjusted to First Notch"

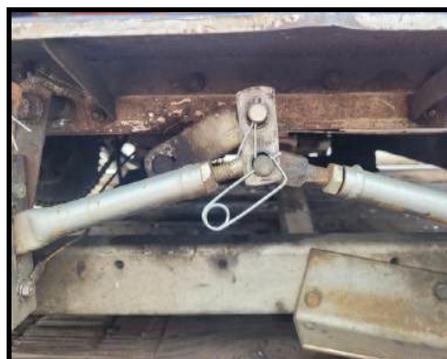
**"Improper Toggle Arm Hardware/
Loose Adjusting Nut"**

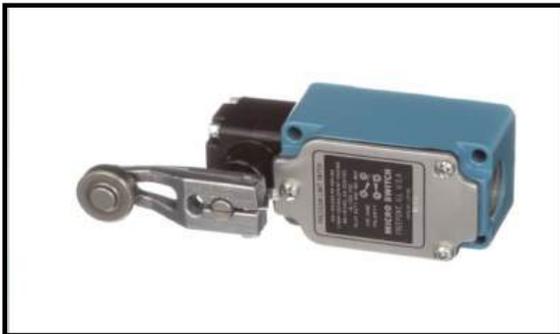
**Required Honeywell 1LS1
Precision Roller Lever Limit Switch**

To ensure the reliability of the audible alarm, visual light, and ignition interlock, all track cars must be equipped with a Honeywell/Micro Switch 1LS1 precision roller lever limit switch to detect when the turntable is out of correspondence/not fully retracted. No other switches will be allowed. Switches such as automotive push button or lever brake light switches, magnetic proximity sensors, or other similar switches not designed for this purpose are prohibited on WCRG excursions.

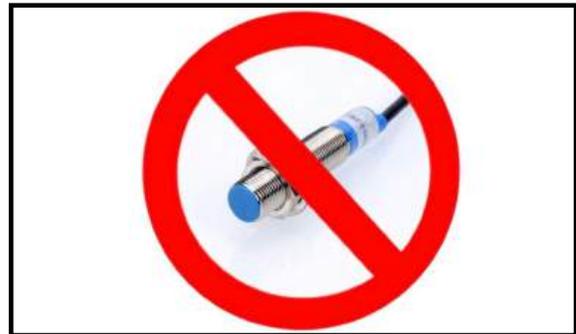
Prohibited Proximity Sensor Switch

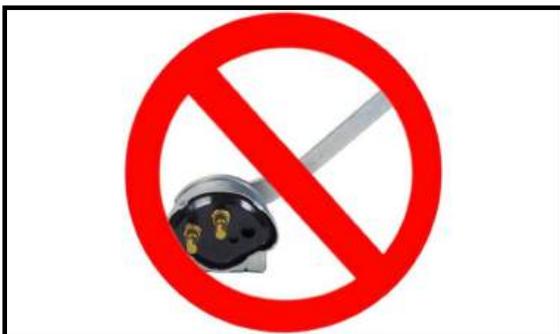
Prohibited Lever Switch

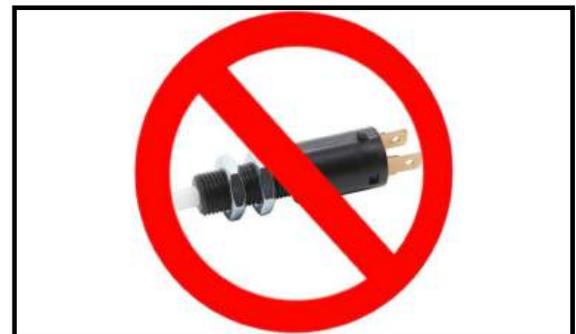
Prohibited Push Button Switch

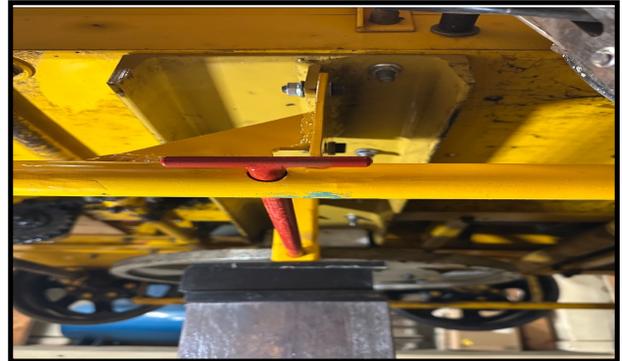
MECHANICAL POSITIVE LOCKING DEVICE

Due to the dangers associated with a baseplate separation and/or gearbox failure, in addition to the "Willits" modification to retain the baseplate, all Les King turntables must be equipped with a mechanical positive locking device to retain the turntable in the fully retracted position on all WCRG excursions.
